REPORT OF INVESTIGATION

Fatal Slip and Fall Accident
September 16, 2007

Mountaineer II Mine
Mingo Logan Coal Company
Sharples, Logan County, West Virginia
I.D. No. 46-09029

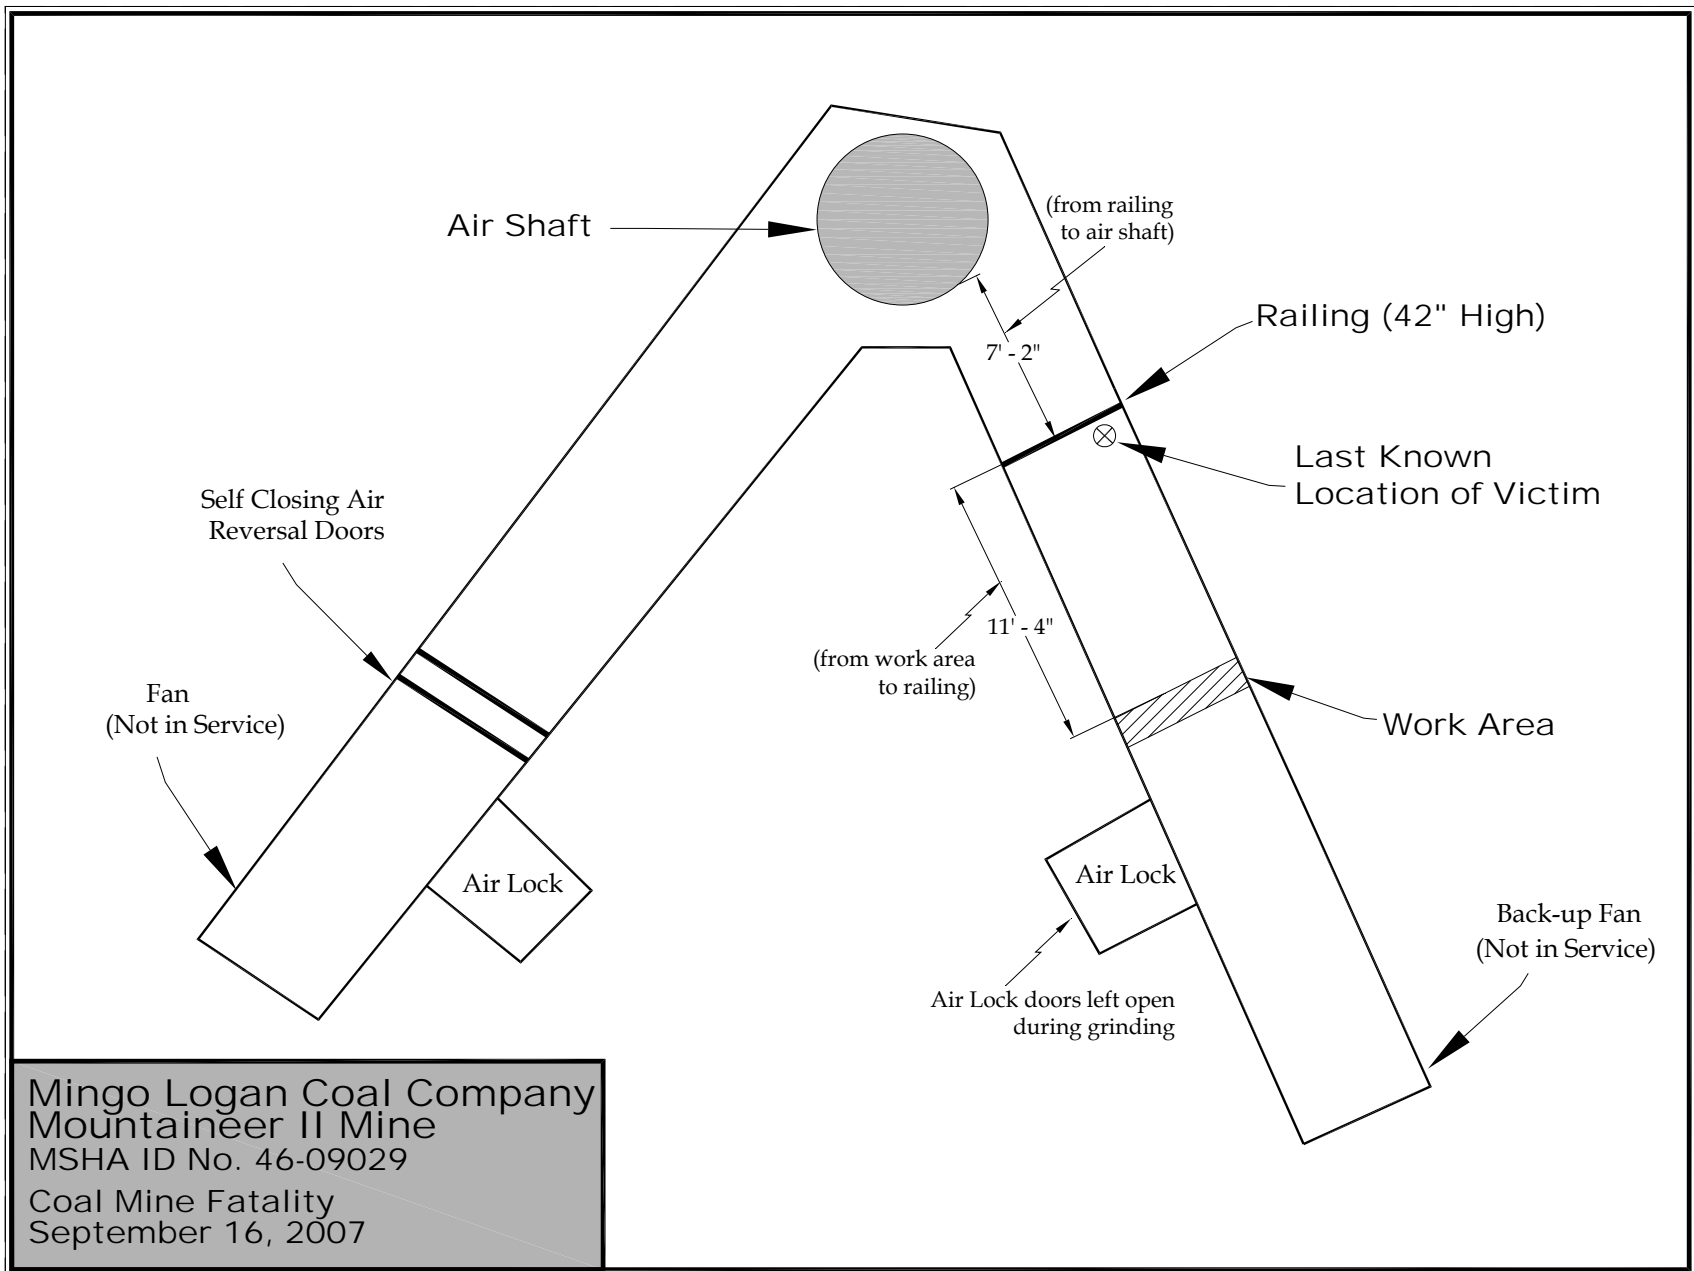
A protective handrail was located approximately 8 feet from the shaft collar to prohibit entry into the area surrounding the ventilation shaft. The handrail extended from wall to wall for a distance of 15 feet and consisted of two horizontal rails and three vertical leg supports. The horizontal components were constructed of 3/4-inch thick cold rolled mild steel. The bases of the vertical supports were anchored to the concrete pad with bolts. The bolts were firmly installed with no obvious play or movement. The upper metal rail was 42-inches above, and parallel to, the concrete floor. The parallel lower rail was 24 inches below the top rail. The spacing of the rails was sufficient to prevent persons from inadvertently falling between the rails. Furthermore, the railing was high enough to prevent persons from falling over the top rail. The protective handrail was well designed and constructed with no obvious flaws or deficiencies.

Concrete floor grinding was being conducted 11 feet from the handrail. The handrail was located between the worksite and the edge of the ventilation shaft. Footing within the work site and the handrail area was smooth, dry, and not slippery. The floor had no
